PHYSICAL CONDITIONS ASSESSMENT FOR

BELL PARK GARDENS OAKLAND GARDENS, NY

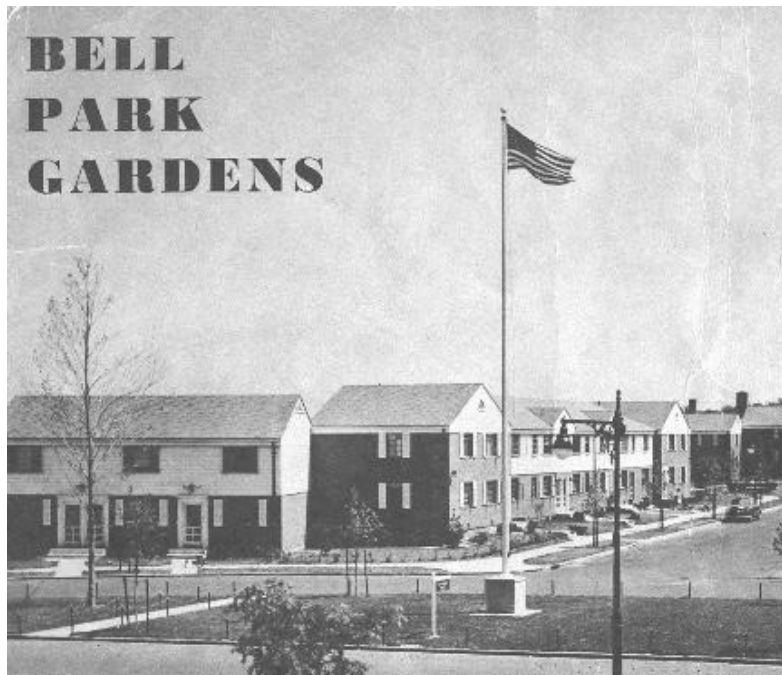
Prepared for:
Bell Park Gardens Board of Directors

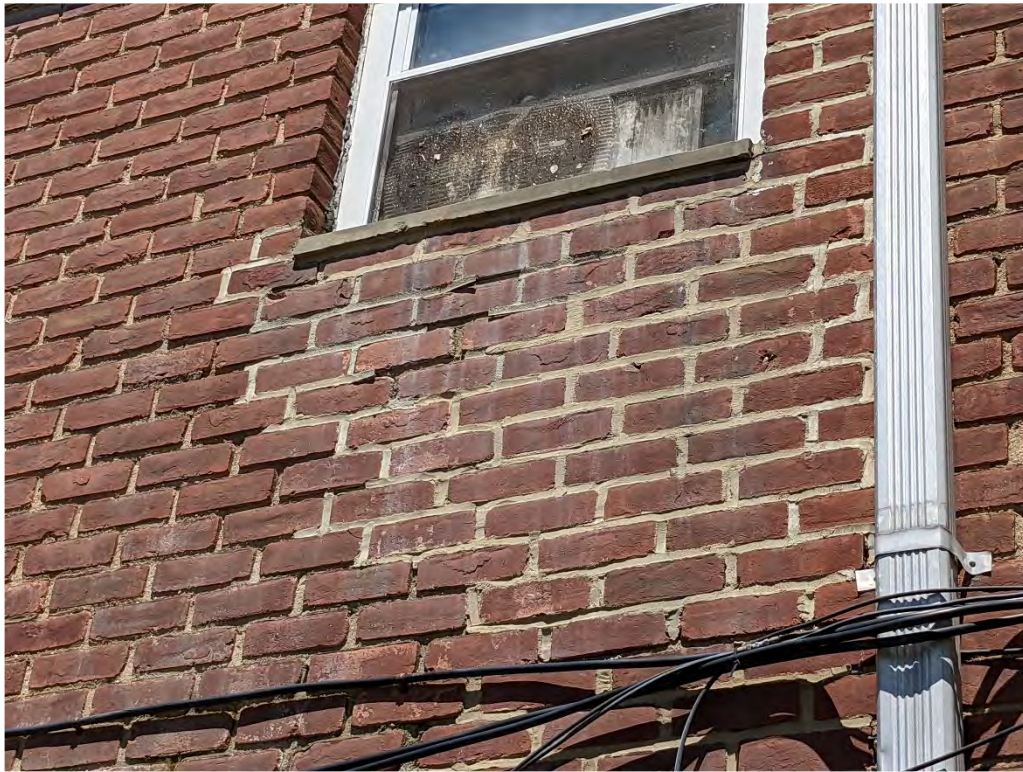
Photo # 1: Deteriorated mortar joints

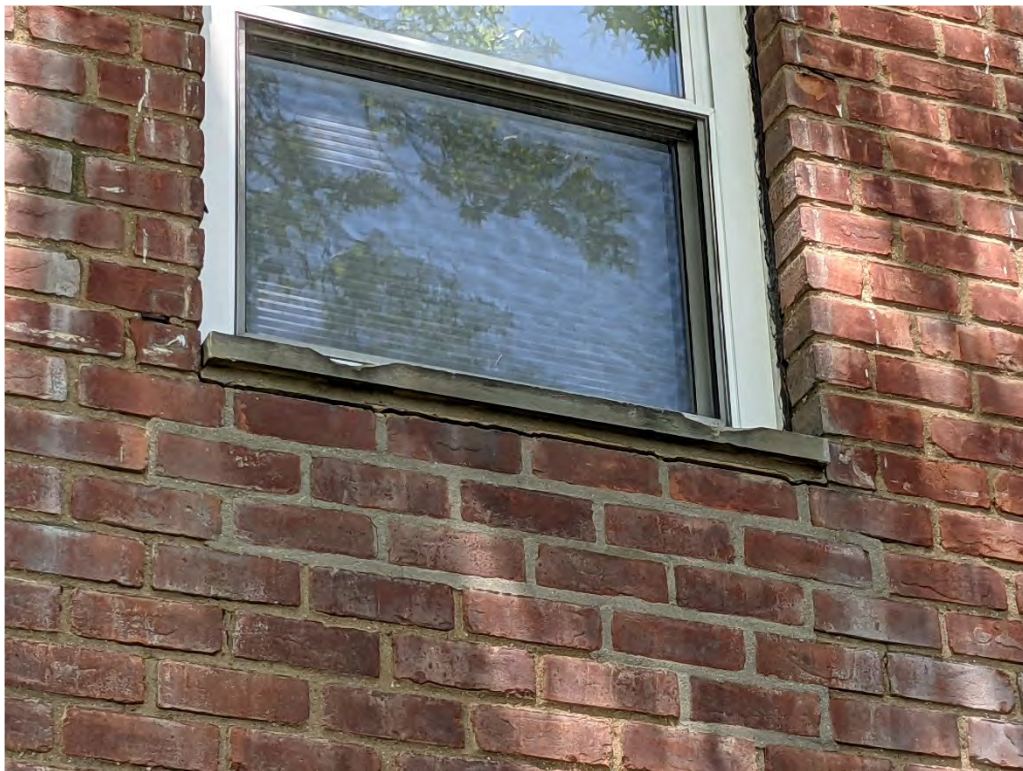
Photo # 2: Open joint at sill

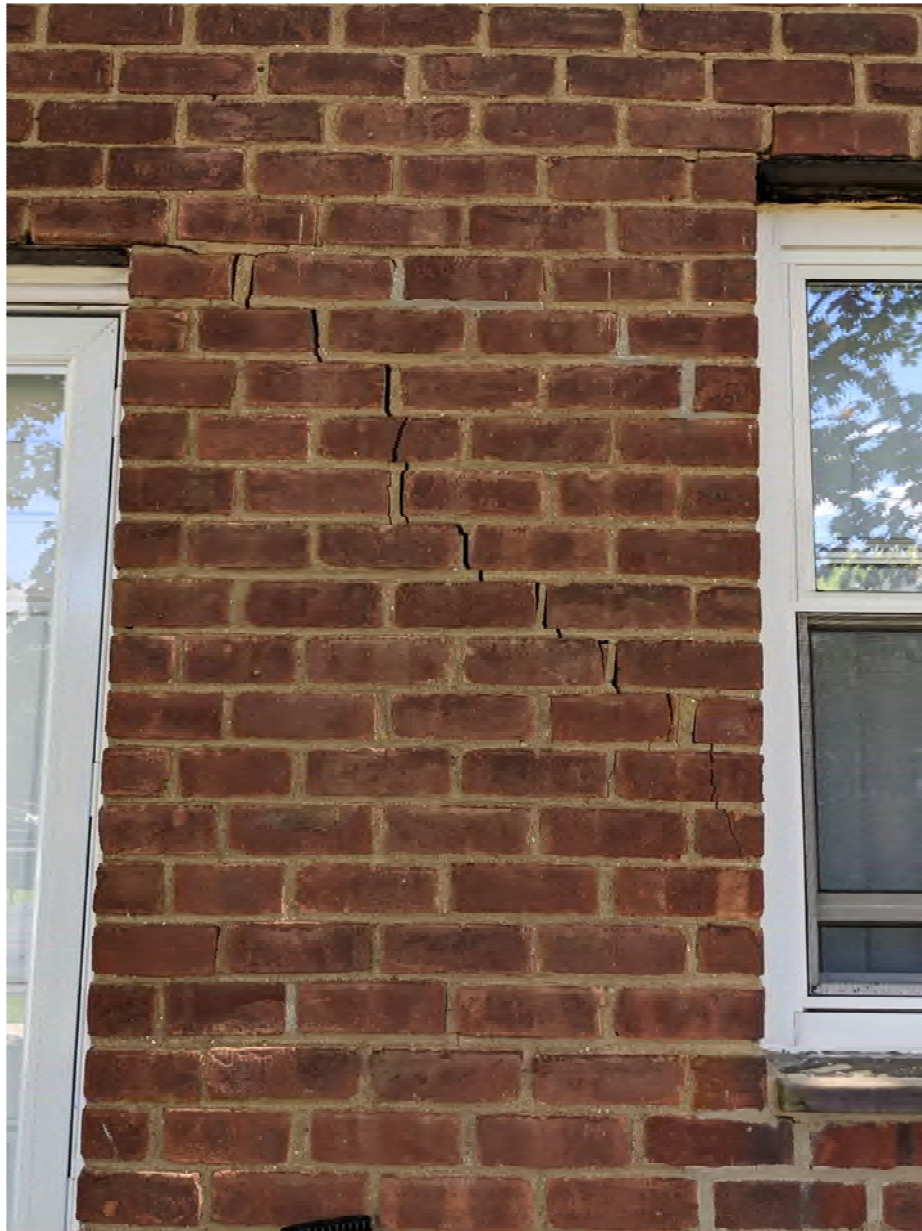
Photo # 3: Open mortar joints and cracked brick

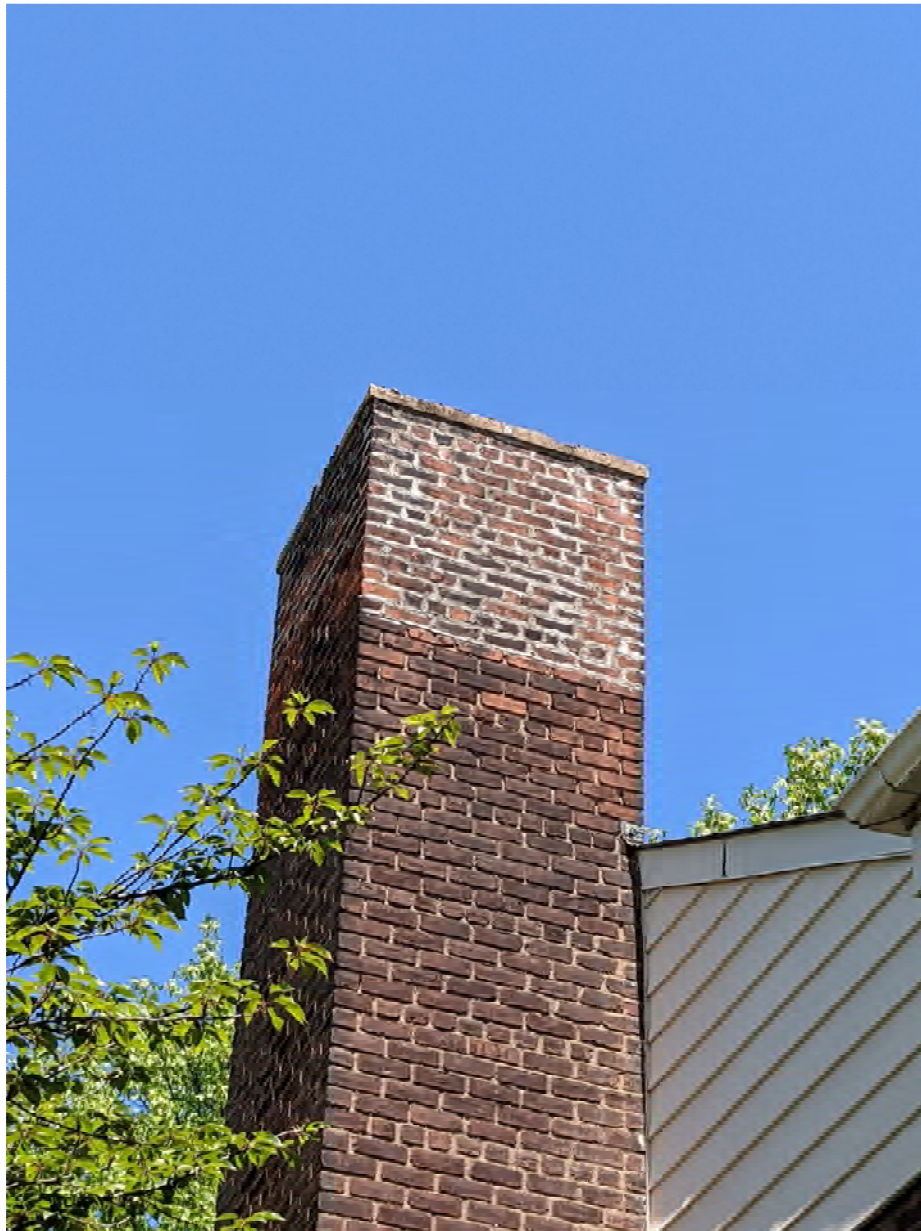
Photo # 4: Deteriorated mortar joints at chimney

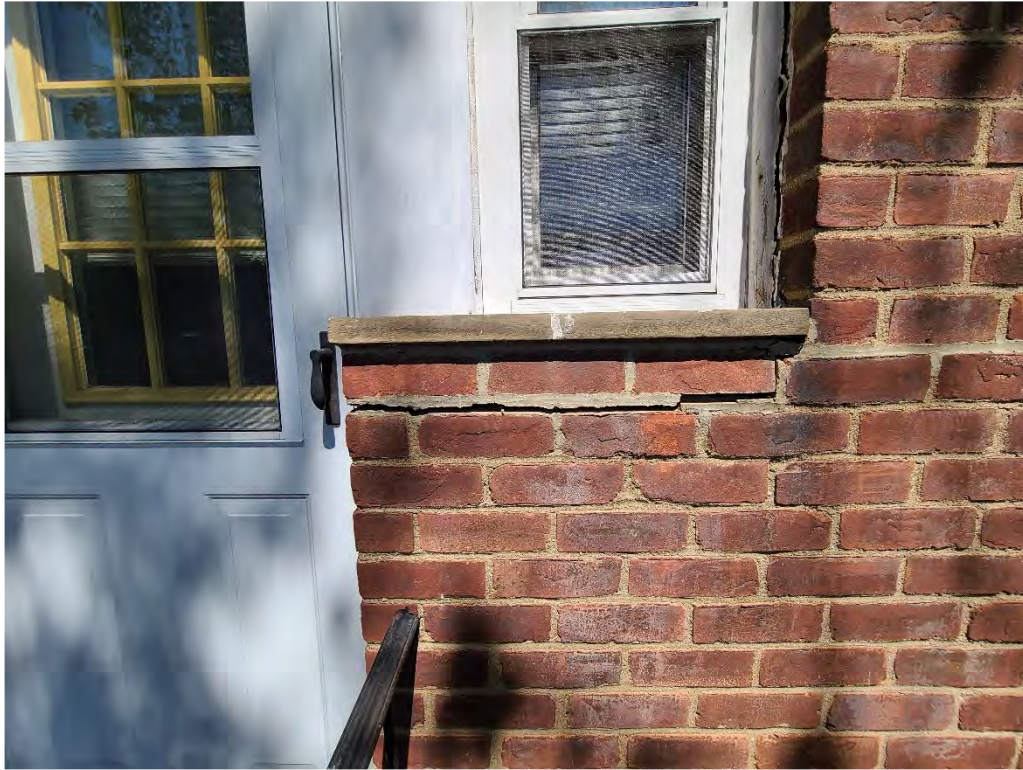
Photo # 5: Open mortar joints

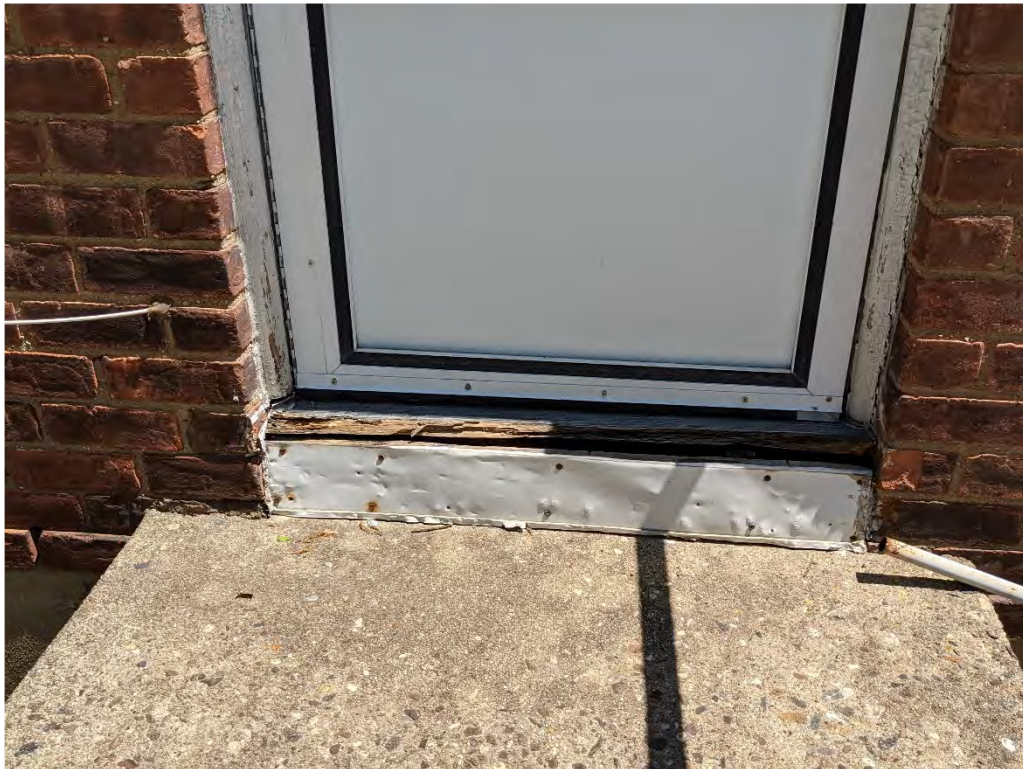
Photo # 6: Deteriorated wood stool

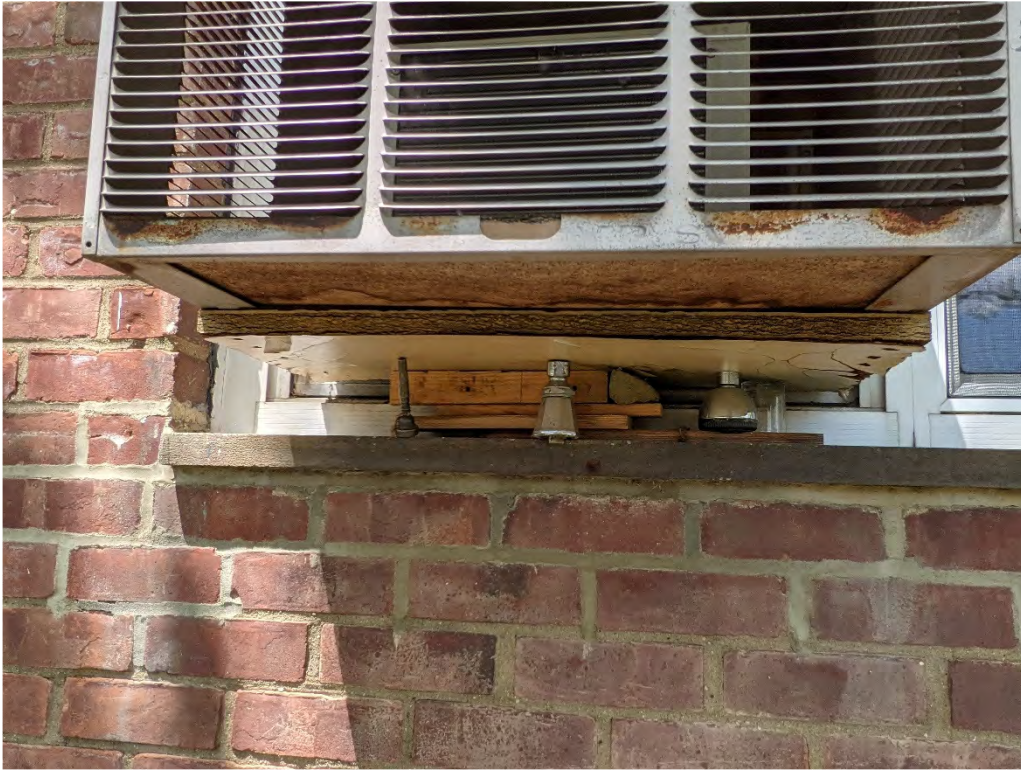
Photo # 7: improper window AC supports.

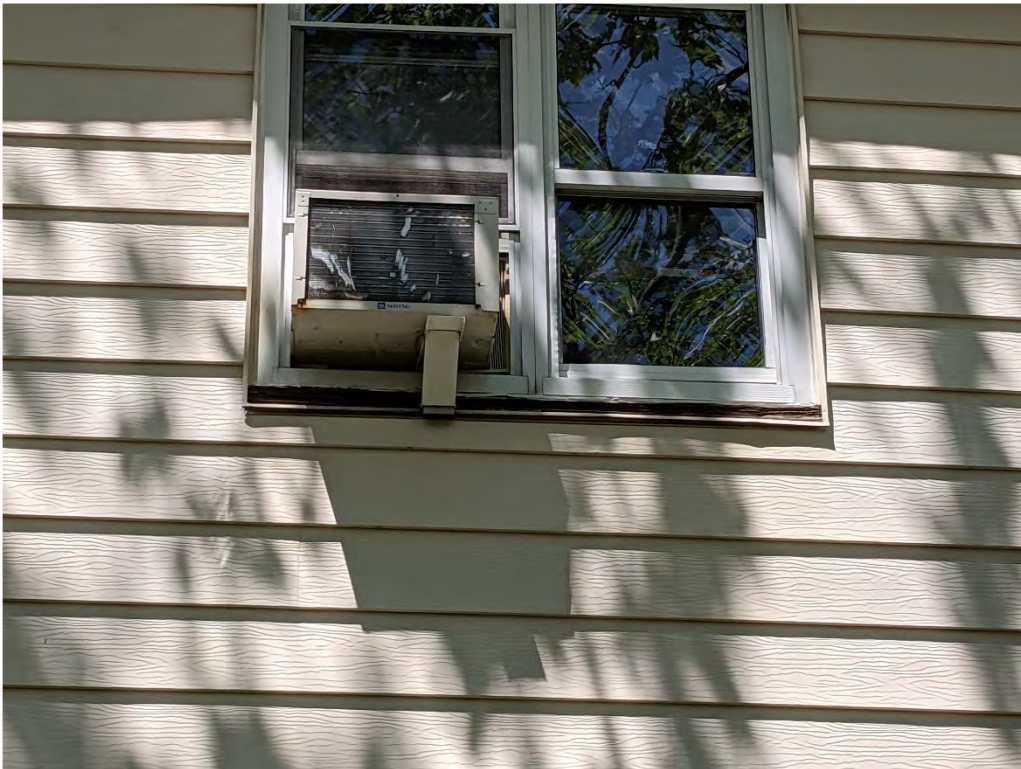
Photo # 8: Deteriorated window sill at siding

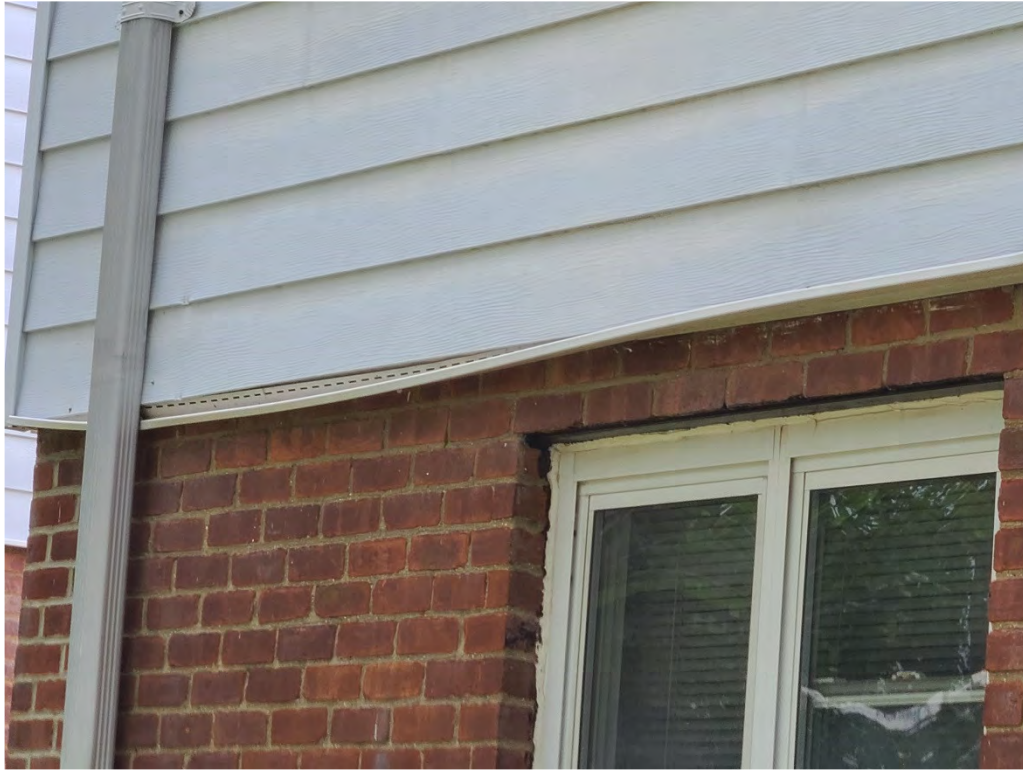
Photo # 9: loose siding trim

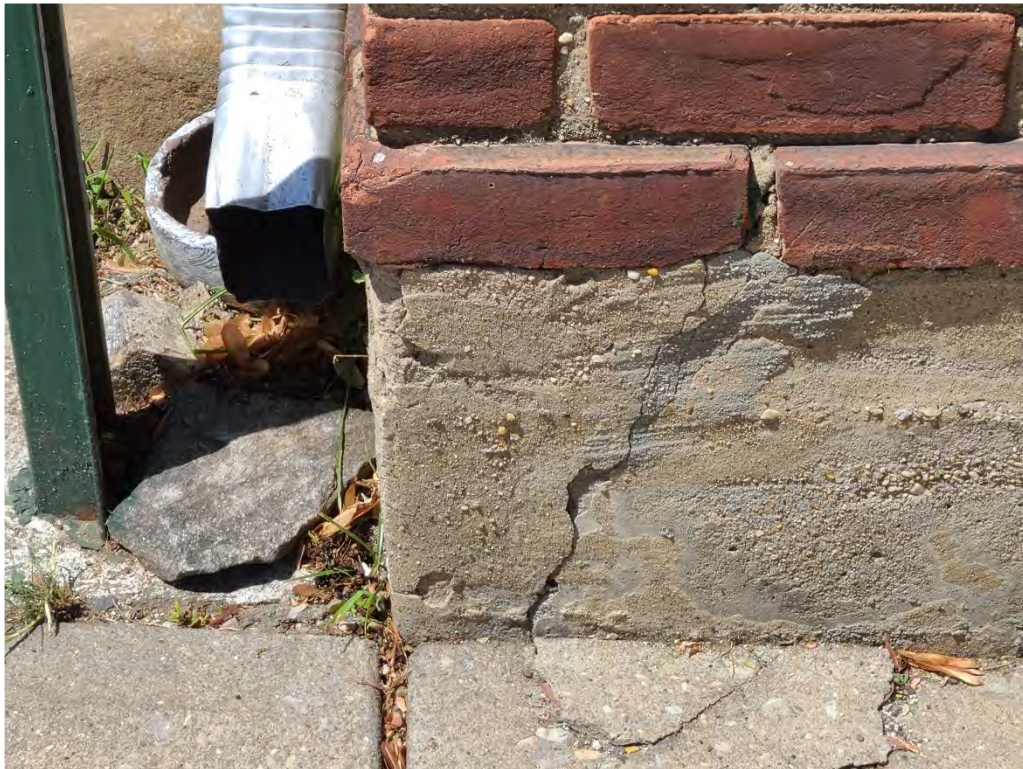
Photo # 10: Deterioration at foundation/stucco finish

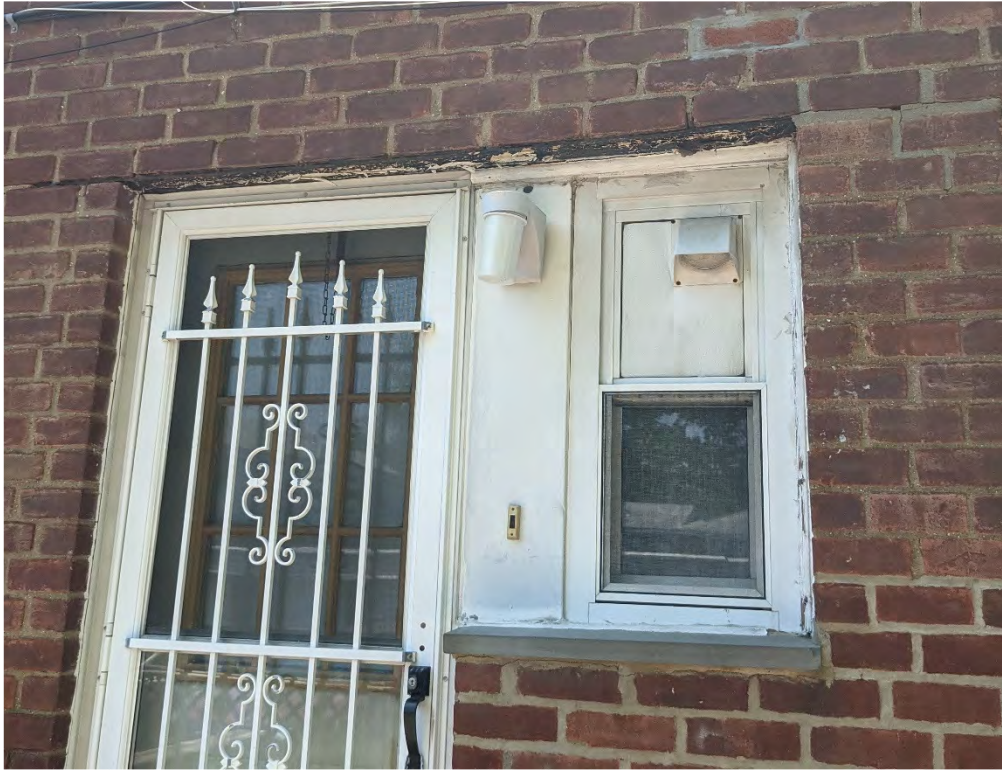
Photo # 11: Deteriorated lintel

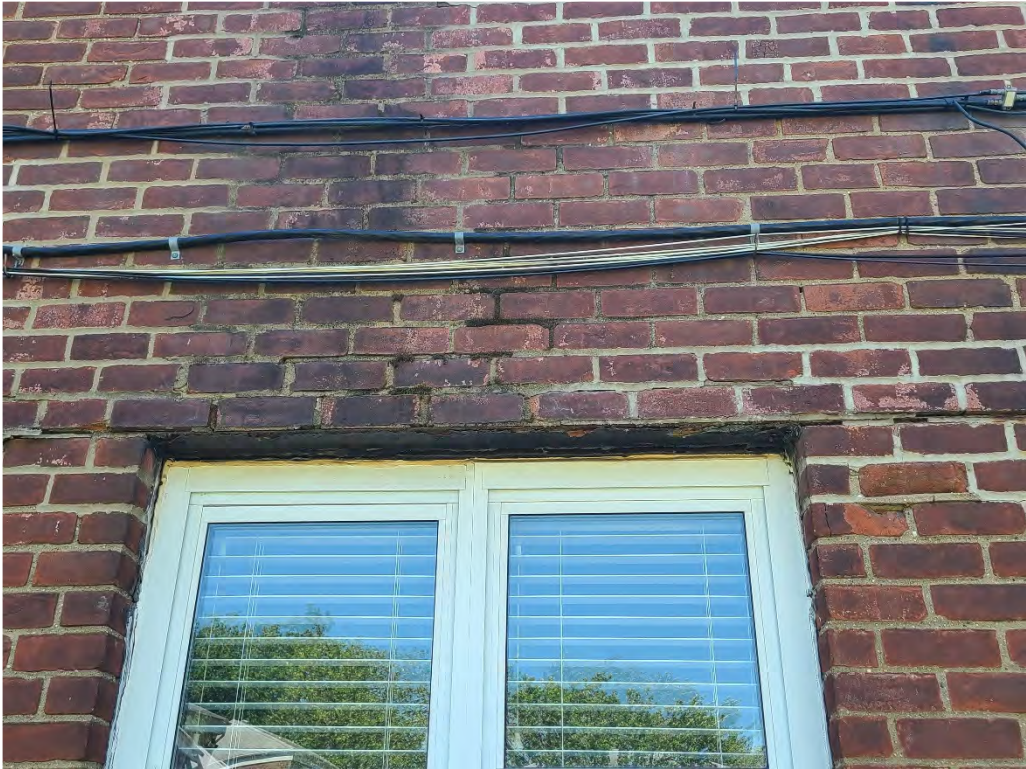
Photo # 12: Deteriorated lintel

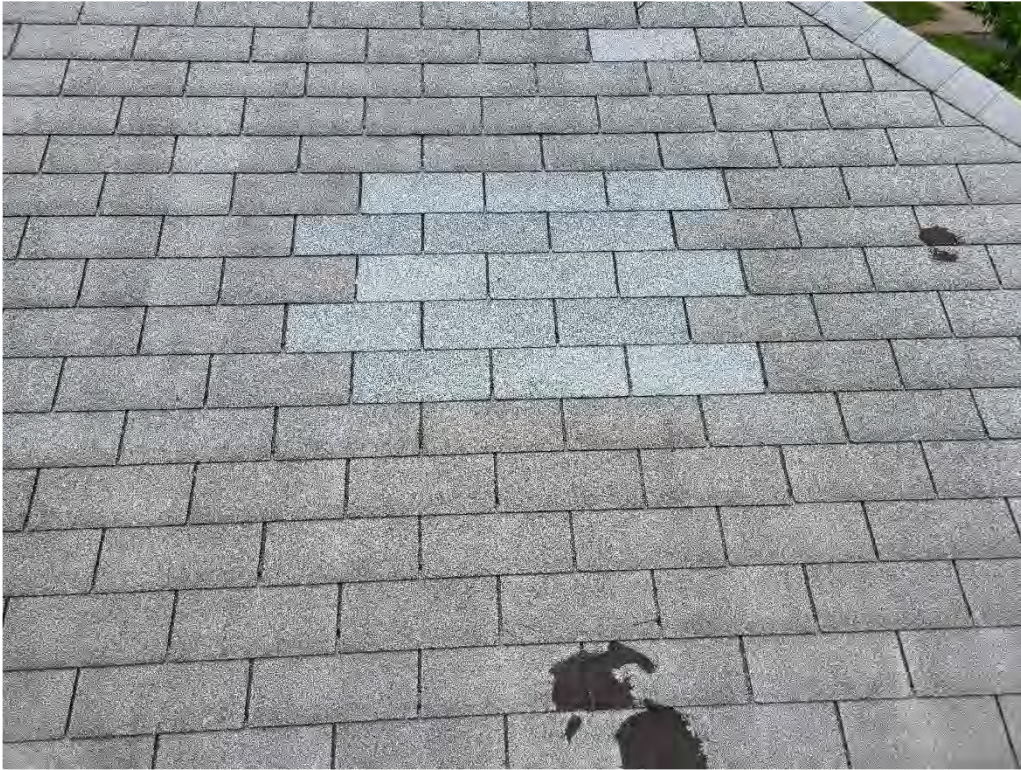
Photo # 1: Roof patches - typical

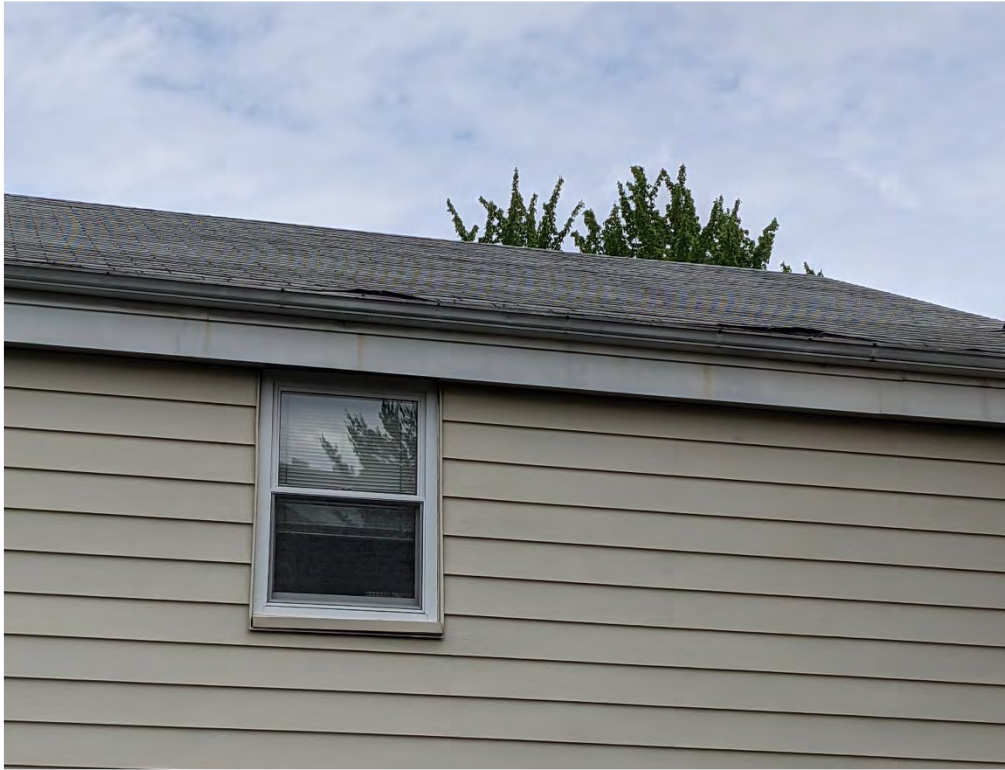
Photo # 3: Deteriorated roofing

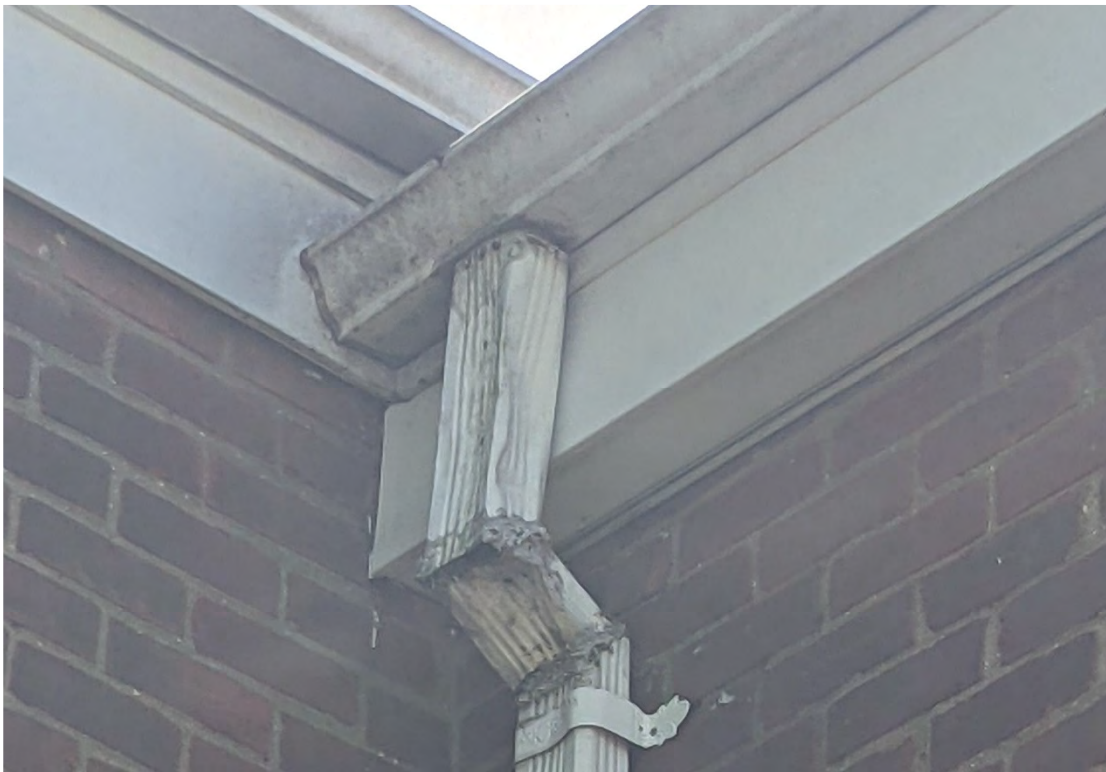
Photo # 4: deteriorated down spouts

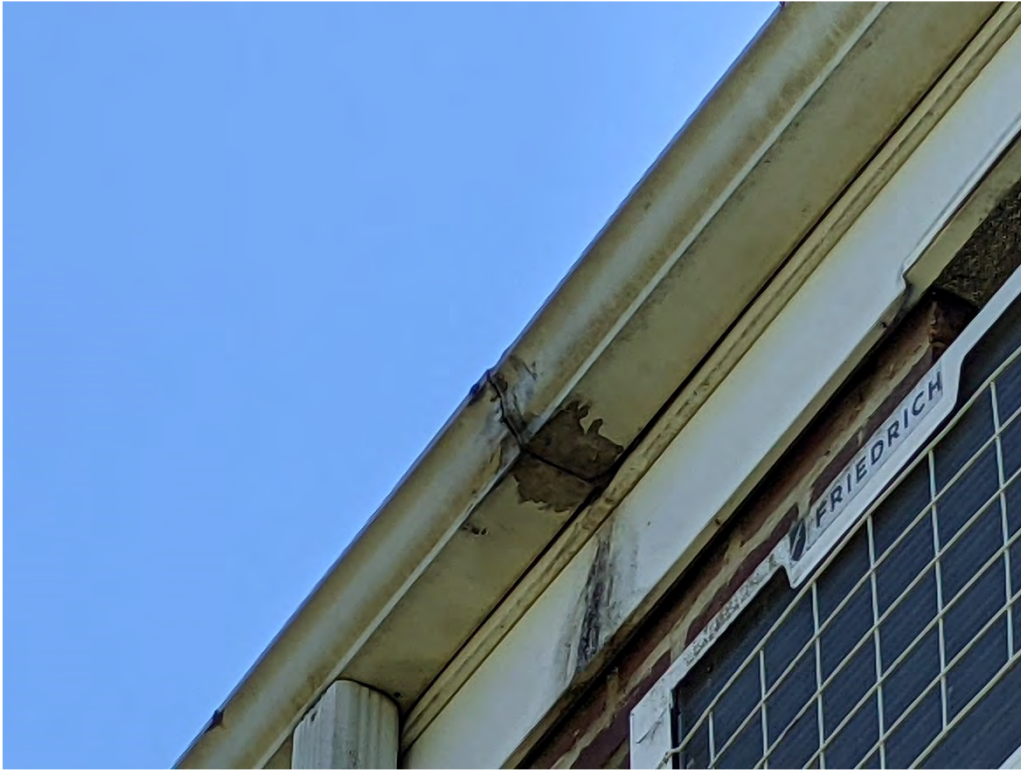
Photo # 5: Deteriorated gutters

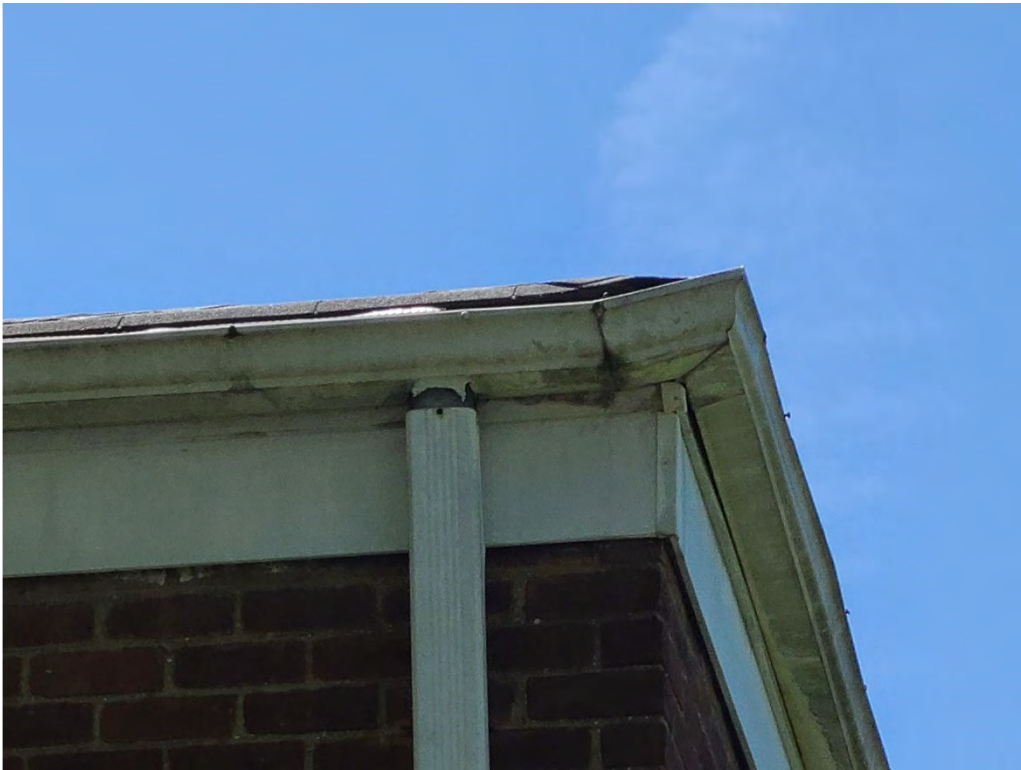
Photo # 6: Deteriorated gutters

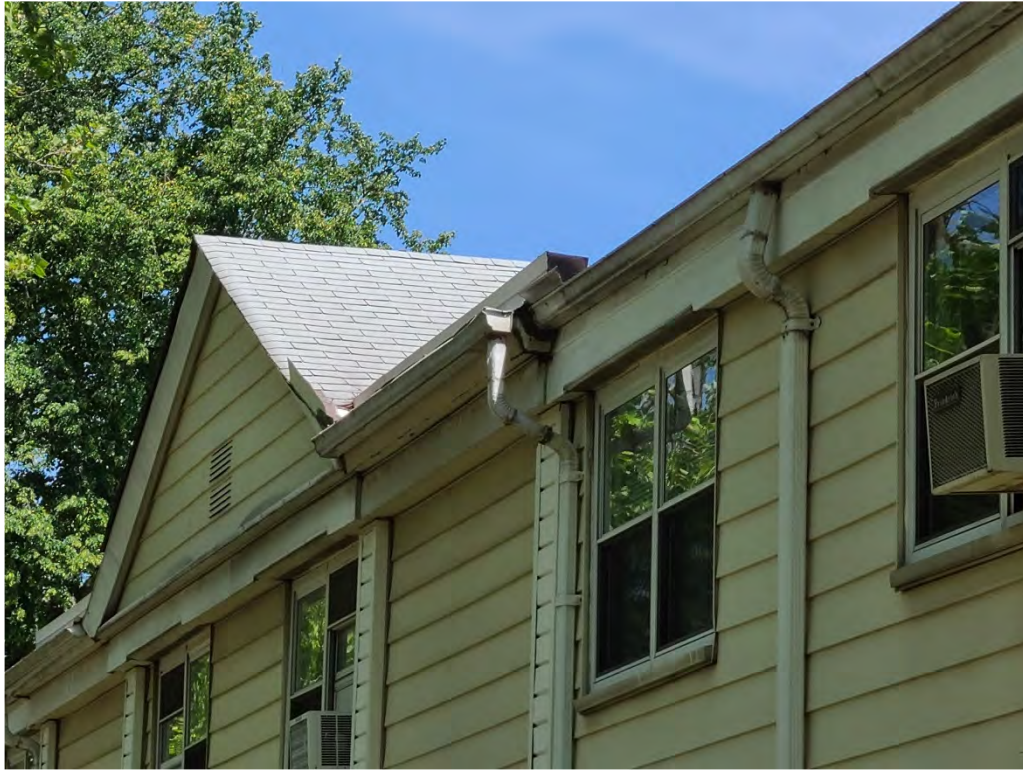
Photo # 7: Water diversion and gutter system

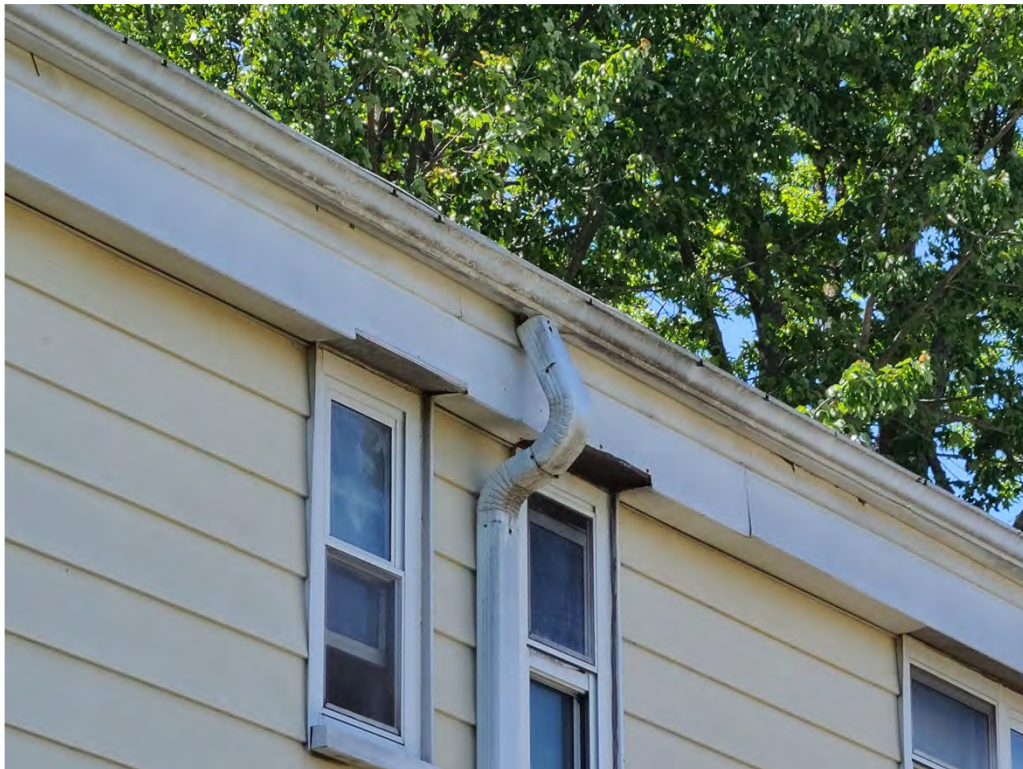
Photo # 8: Deteriorated gutters

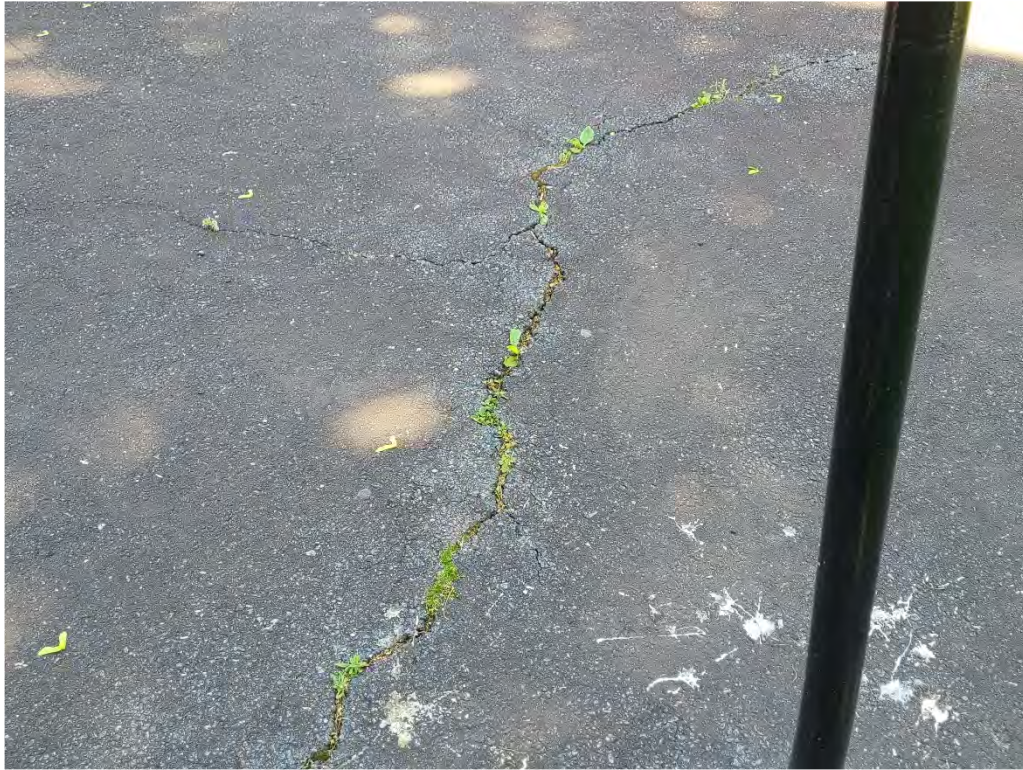
Photo # 1: Crack at asphalt - Bldg. 24

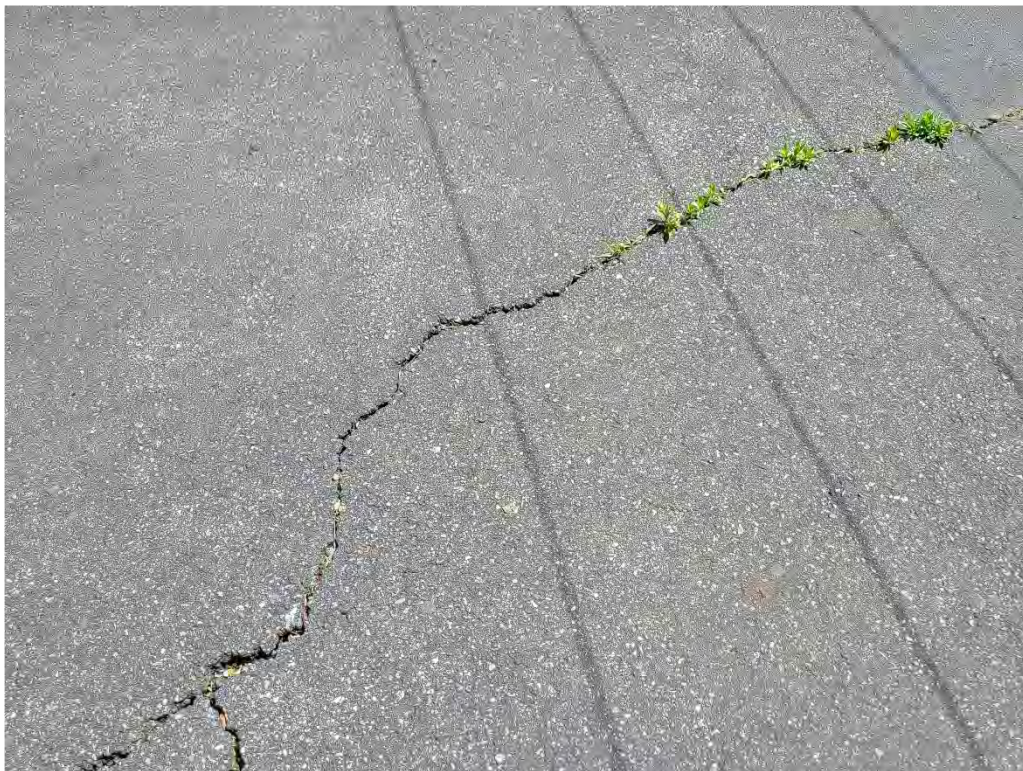
Photo # 2: Crack at asphalt – Bldg. 32

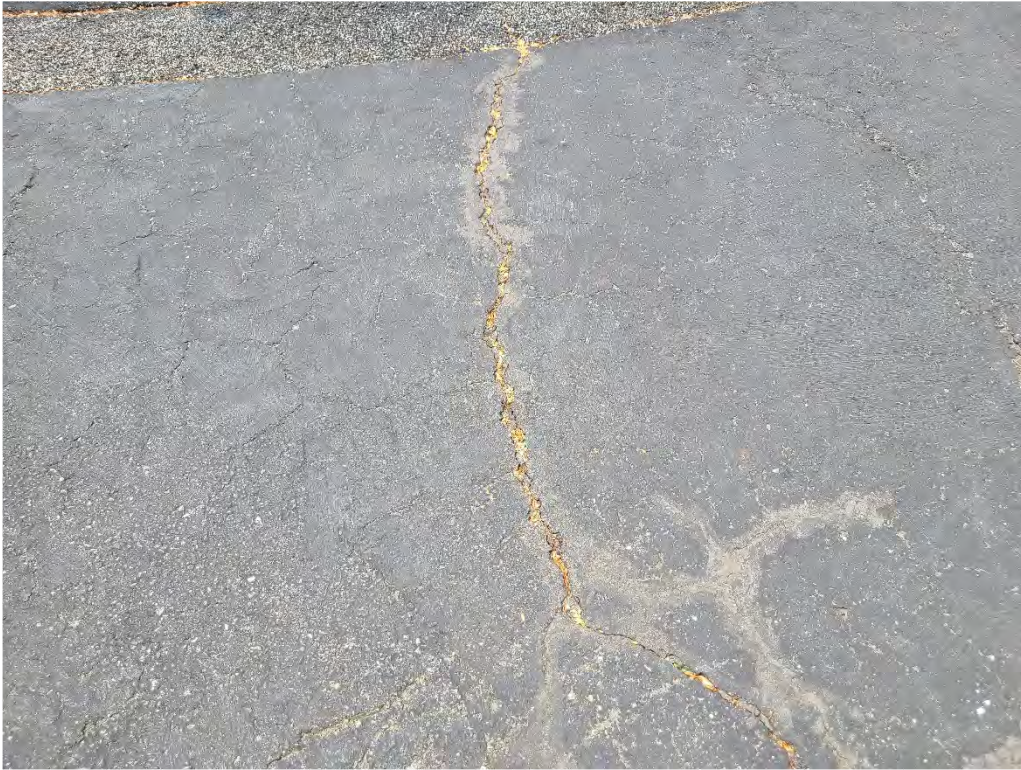
Photo # 3: Crack at asphalt - Bldg. 13

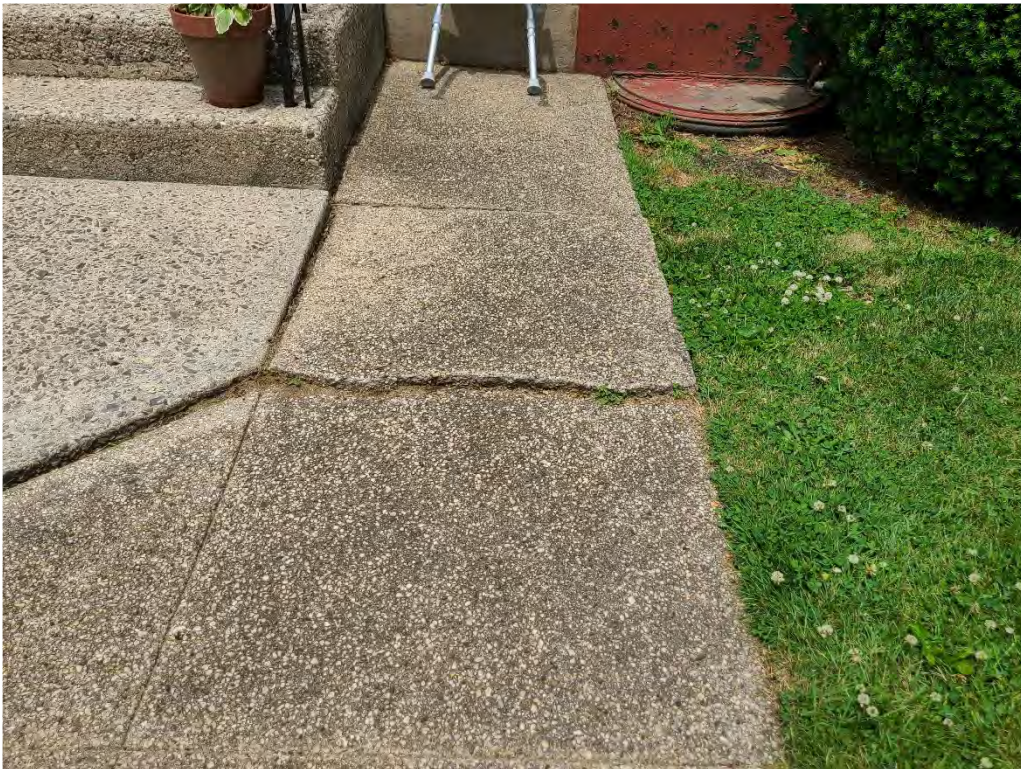
Photo # 4: Cracked/Heaved concrete flag - Bldg. 39

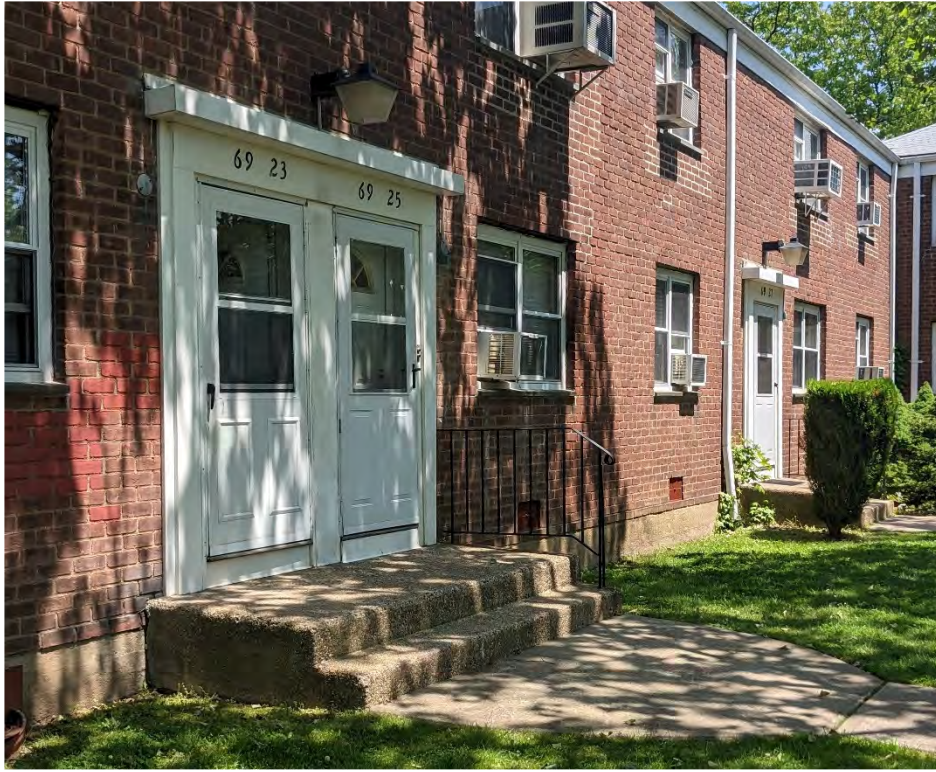
Photo # 5: missing hand rail - Bldg. 21

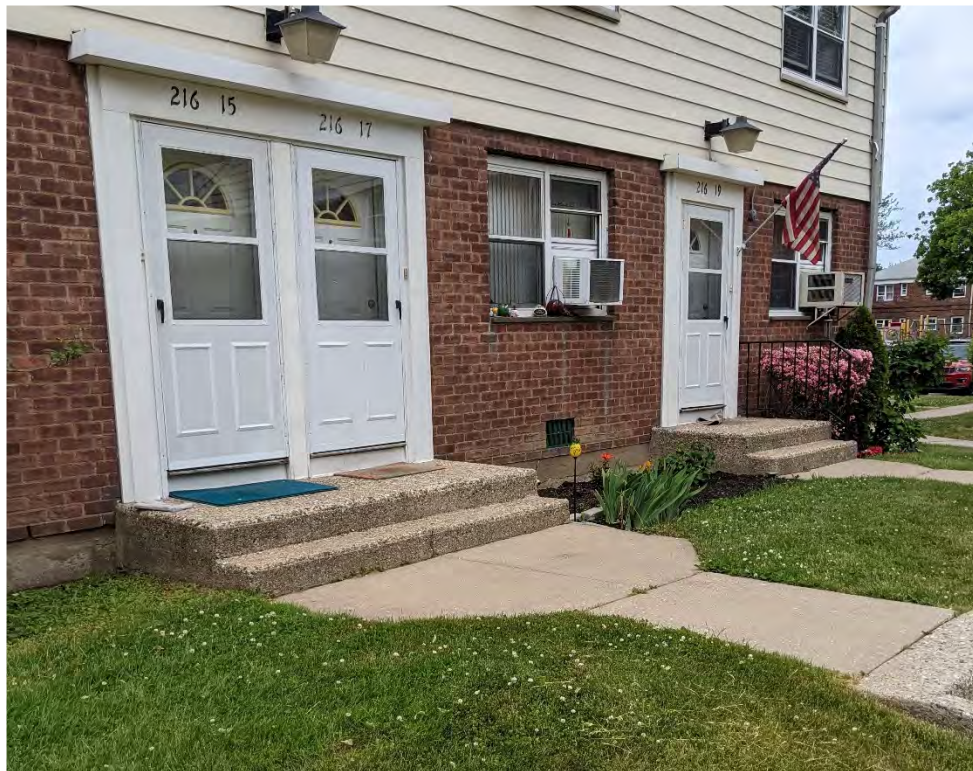
Photo # 6: missing handrails - Bldg. 32

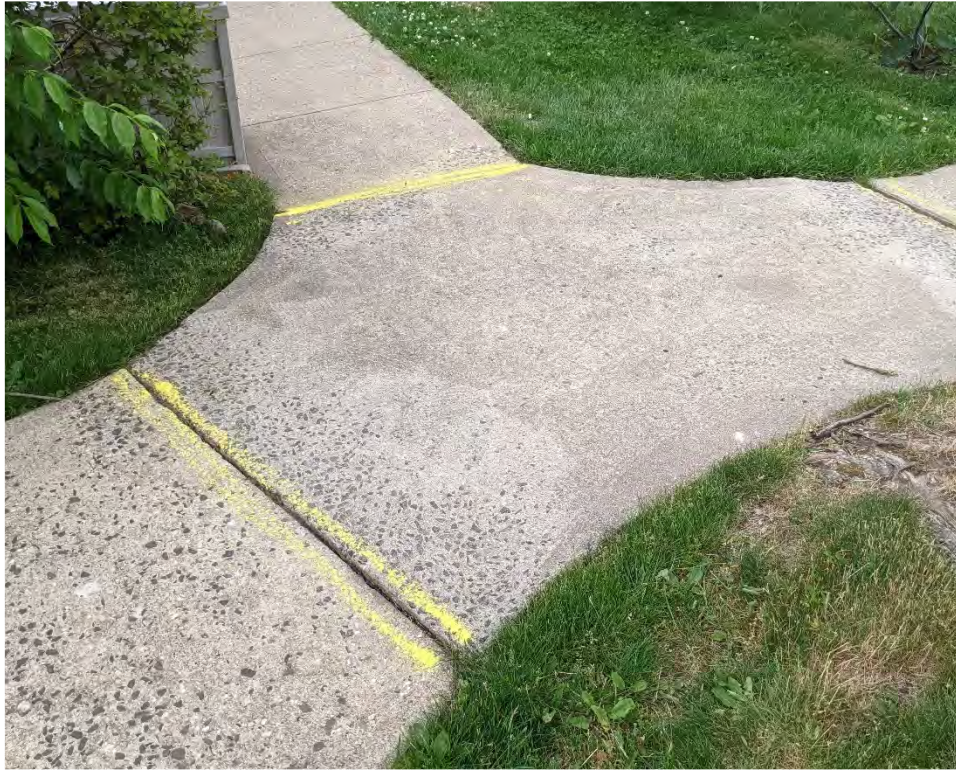
Photo # 7: heaved concrete flag - Bldg. 24

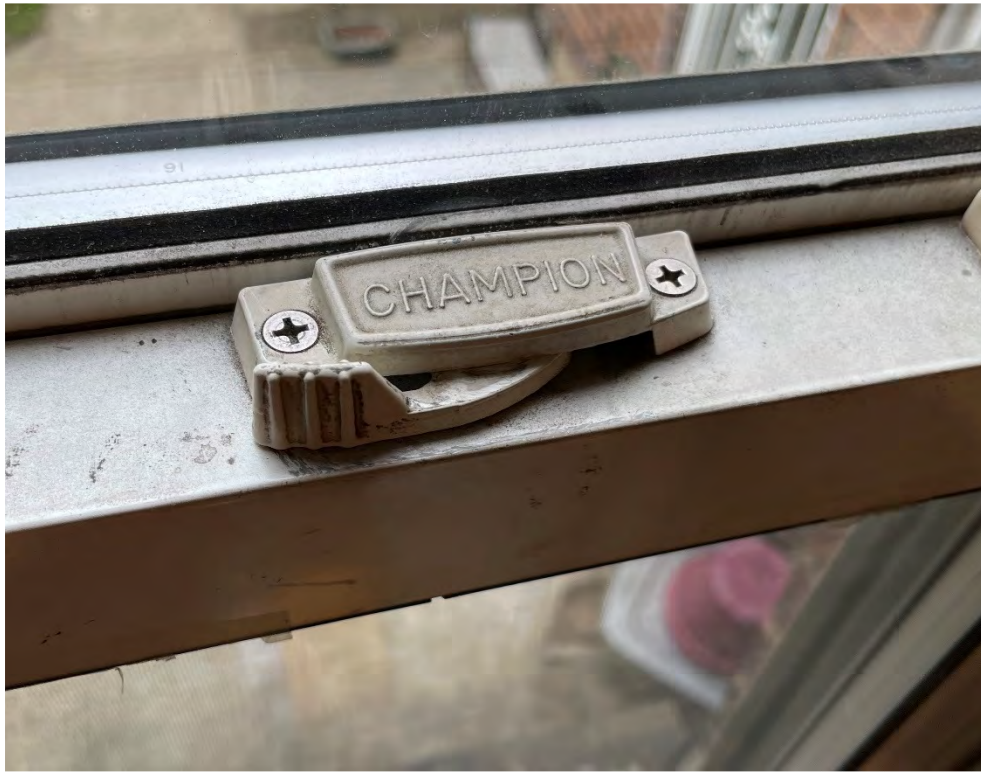
Photo # 1: Replacement Champion Windows throughout the complex

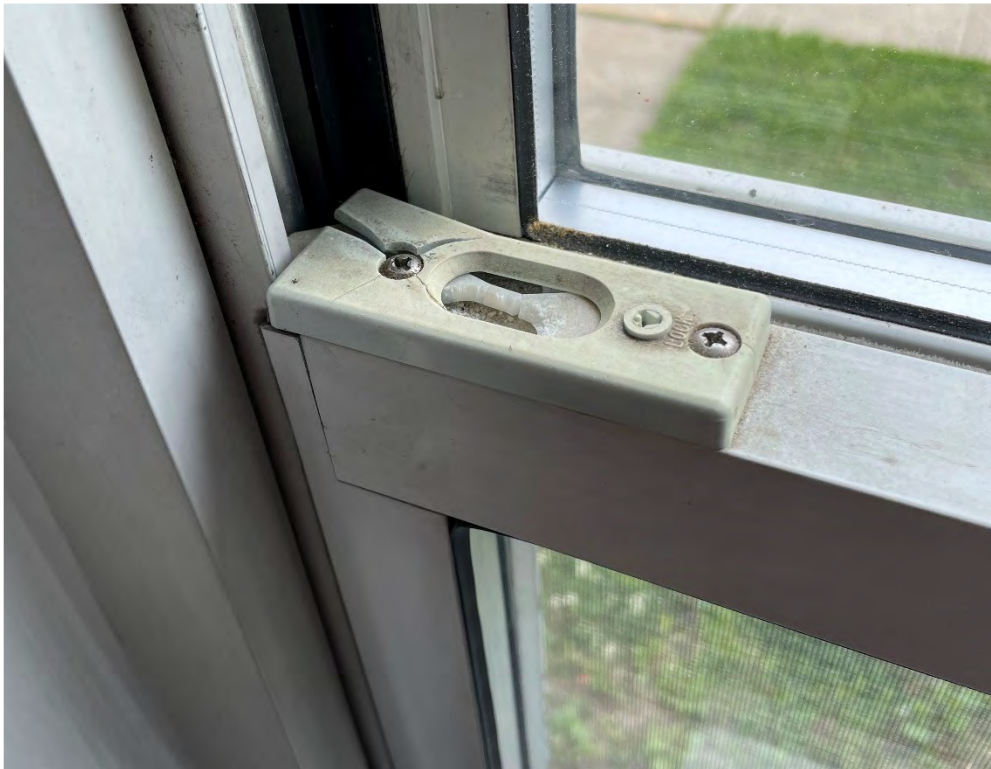
Photo # 2: Damaged tilt latch
