PHYSICAL CONDITIONS ASSESSMENT FOR

BELL PARK GARDENS OAKLAND GARDENS, NY

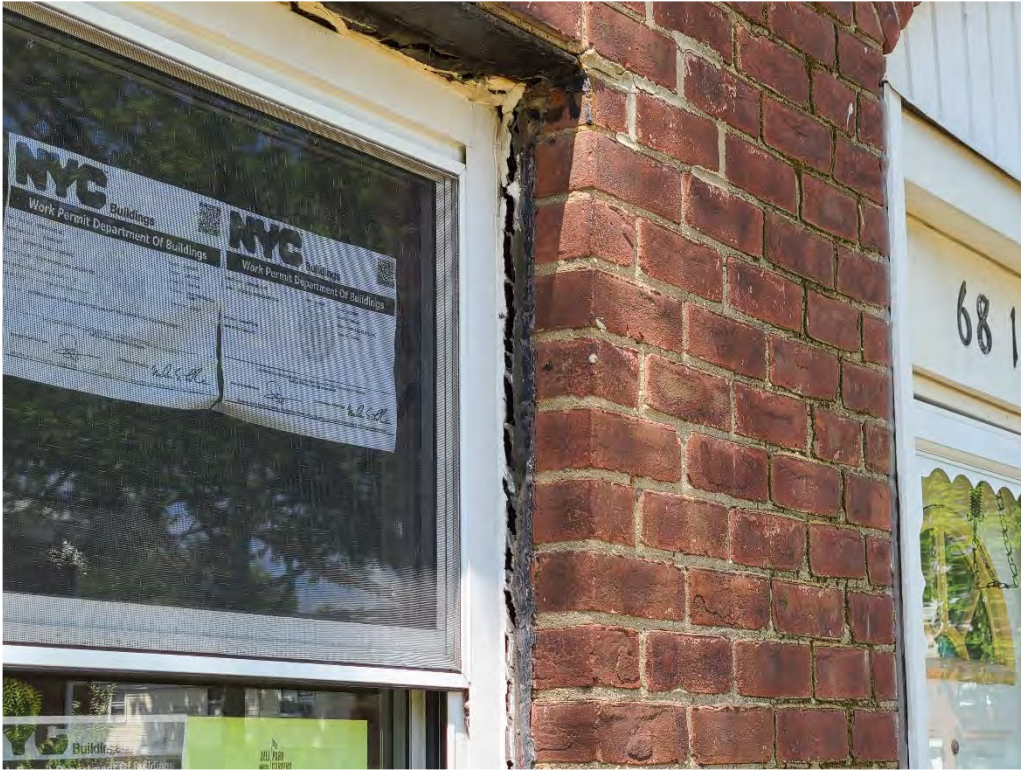
Photo # 3: Deteriorated window caulk

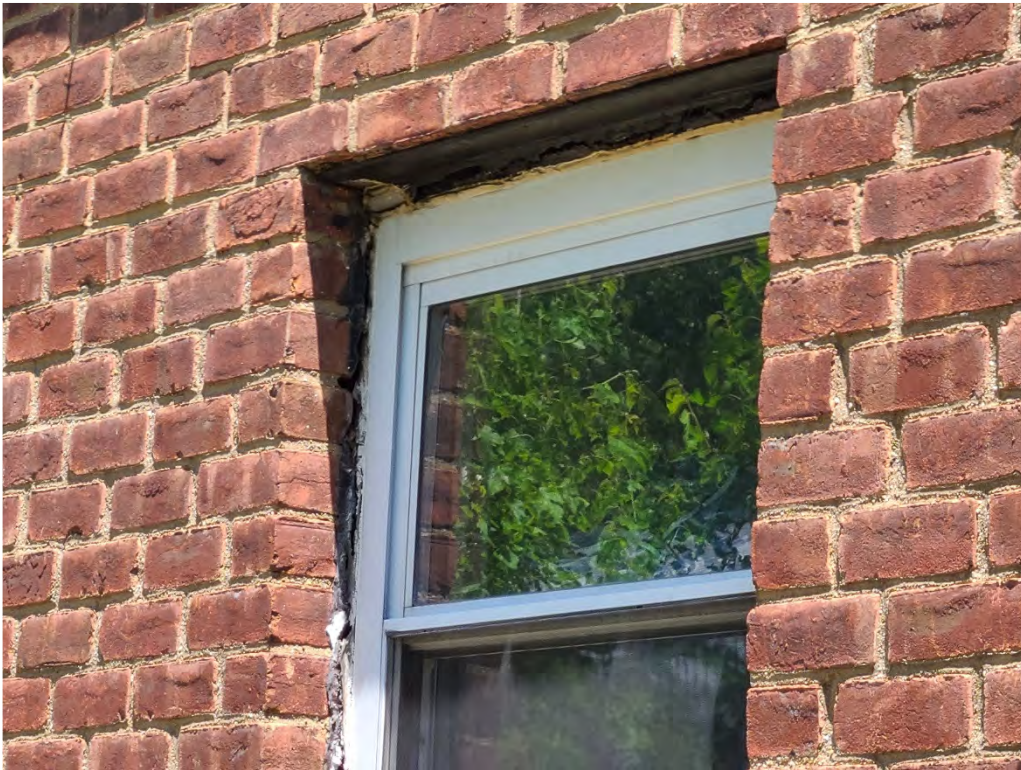
Photo # 4: Deteriorated window caulk

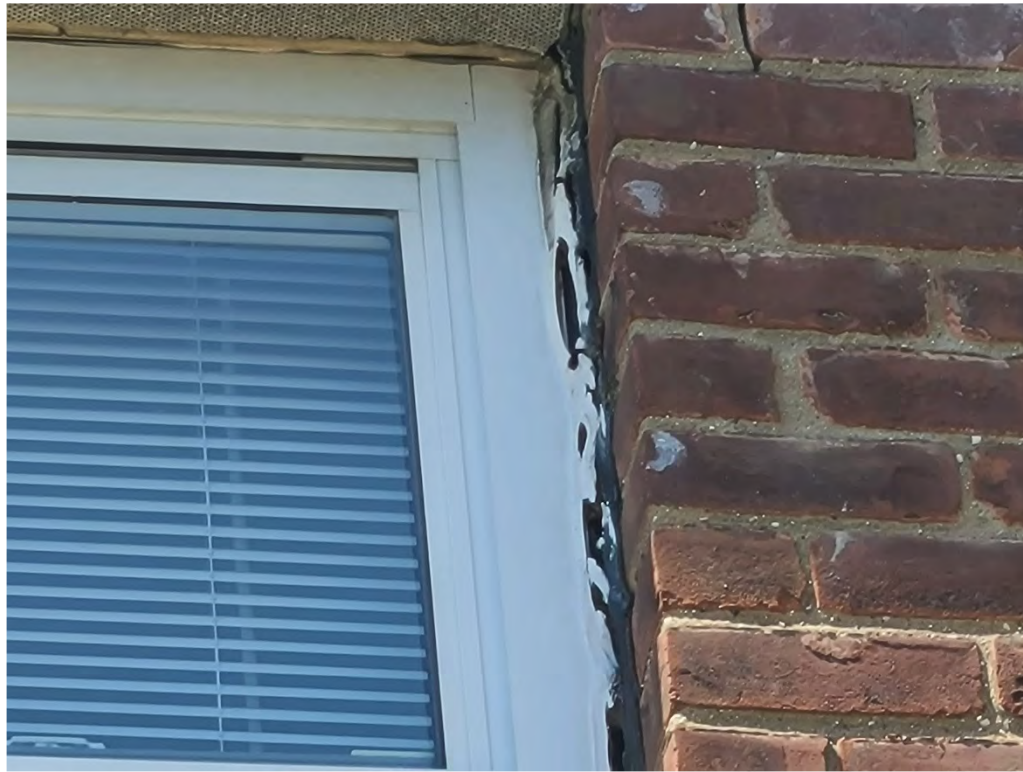
Photo # 5: Deteriorated window caulk

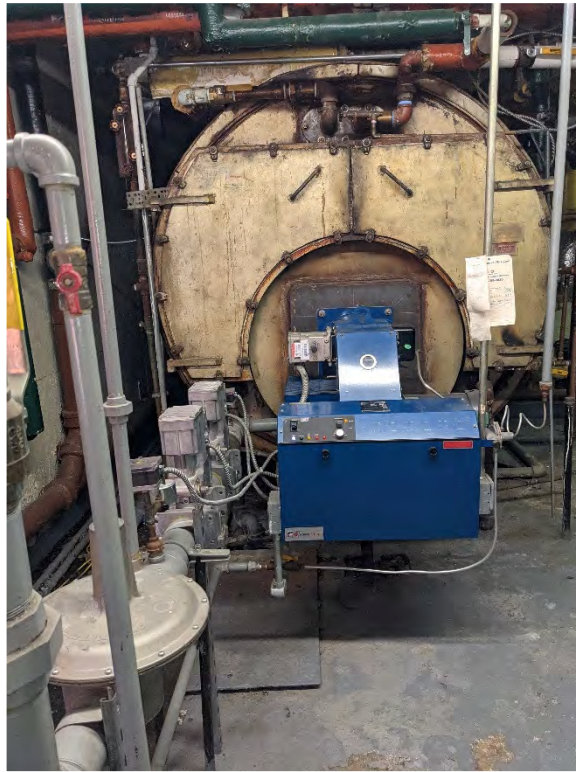
Photo #1: Typical Boiler and Burner

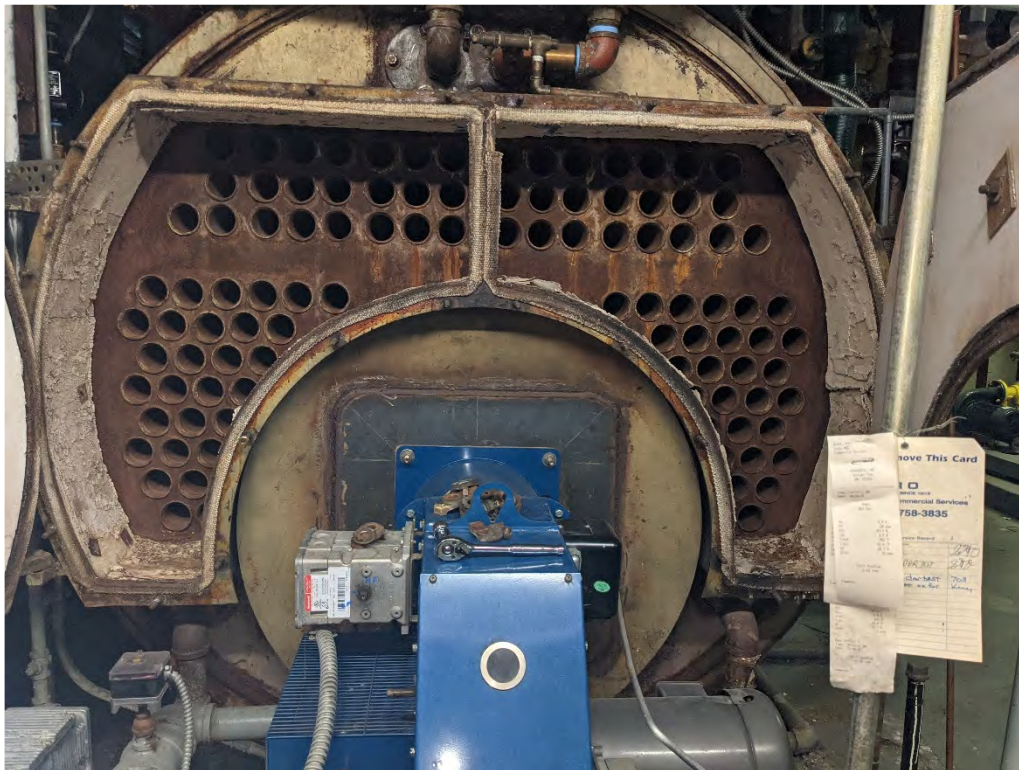
Photo #2: Typical Boiler with access door open

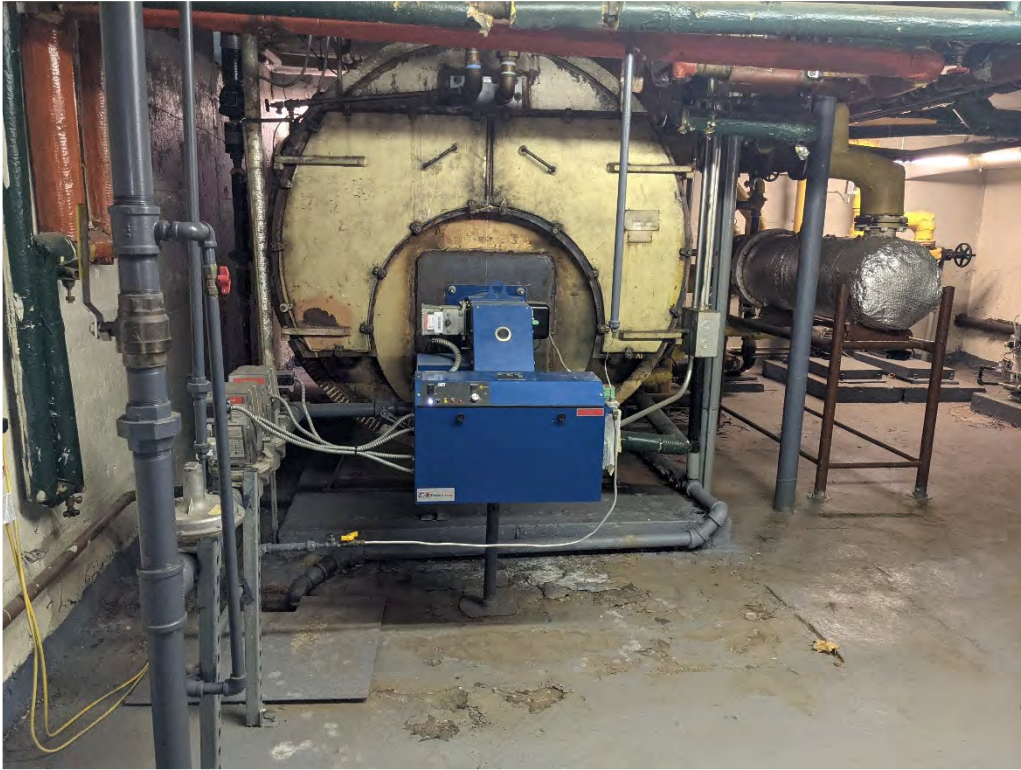
Photo #3: Typical Boiler, Burner, and Heat Exchanger

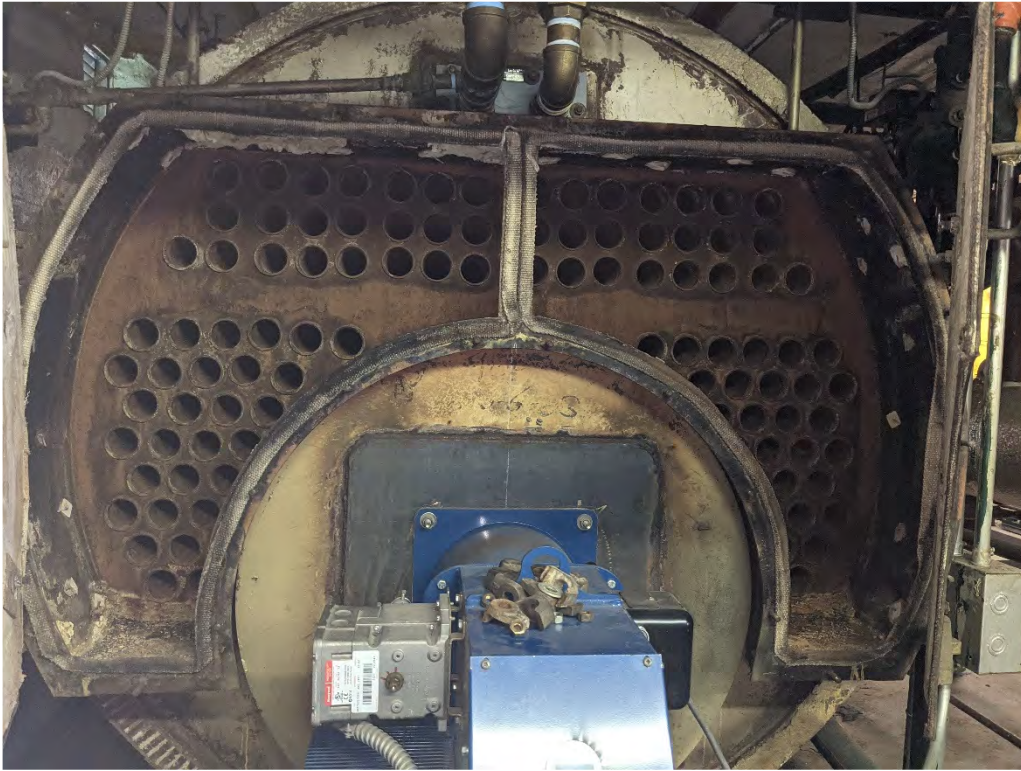
Photo #4: Typical Boiler with Access Door Open

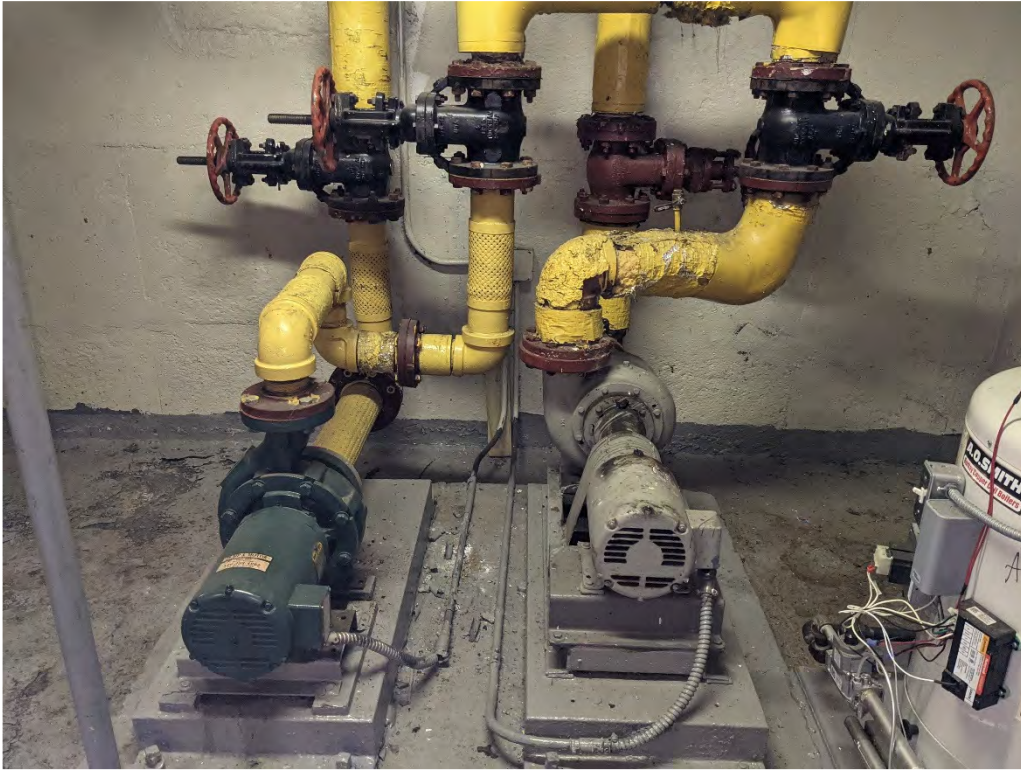
Photo #7: Typical Heating Hot Water Circulation Pumps (Replaced Pump & Original Pump)

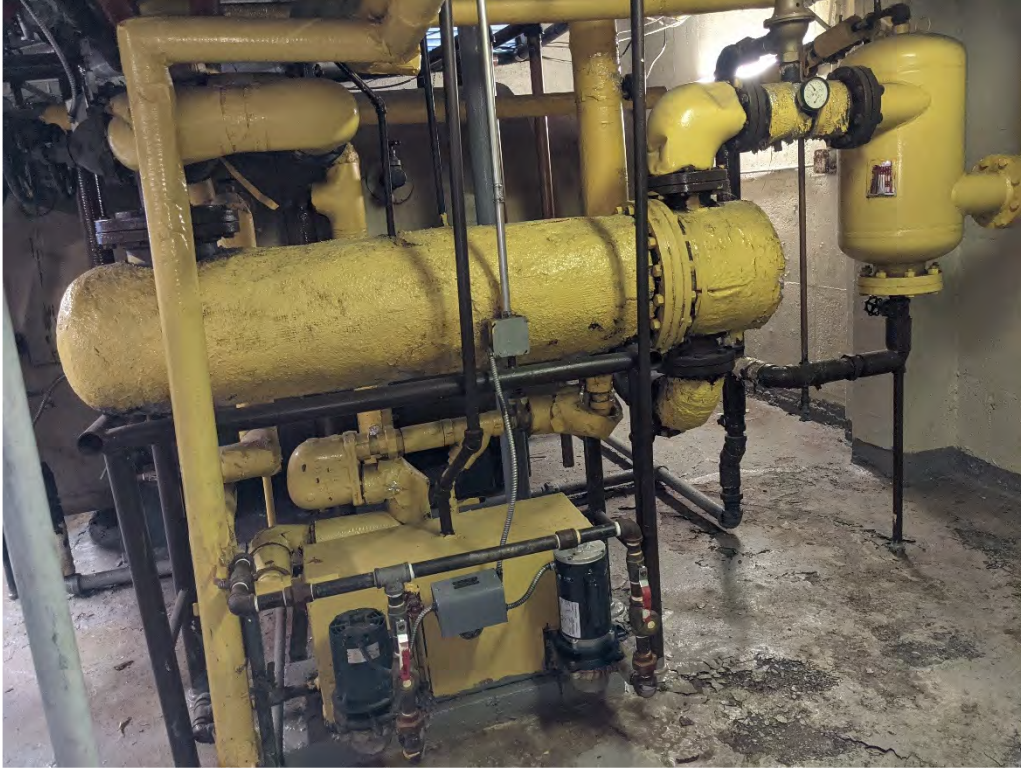
Photo #8: Typical Steam to Hot Water Heat Exchanger, Condensate Pump & Air Separator

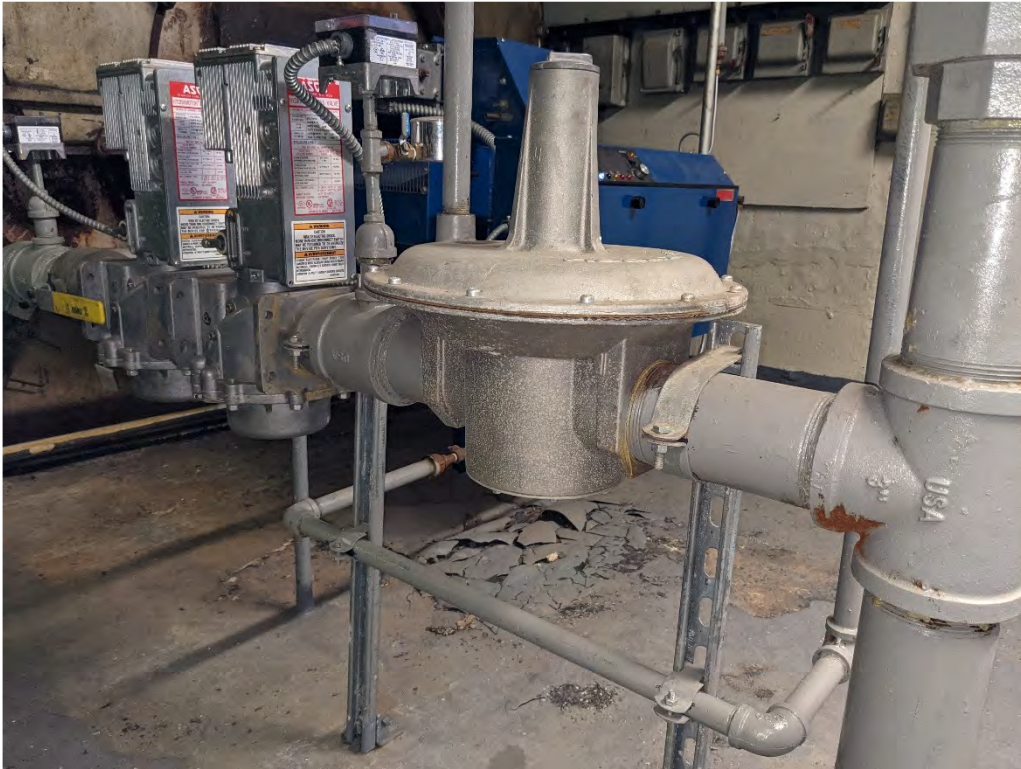
Photo #12: Typical Boiler Gas Train
